FACILITY COMPLIANCE INSPECTION REPORT

Division of Waste Management Solid Waste Section

Dennis Hoyle Services
7337 Reeps Grove Church Rd.
Vale, NC 28168

Comprehensive Site Inspection

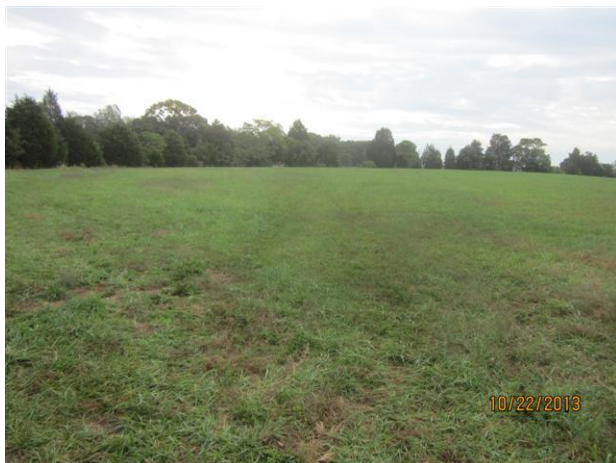
1. Looking SE across field #1.

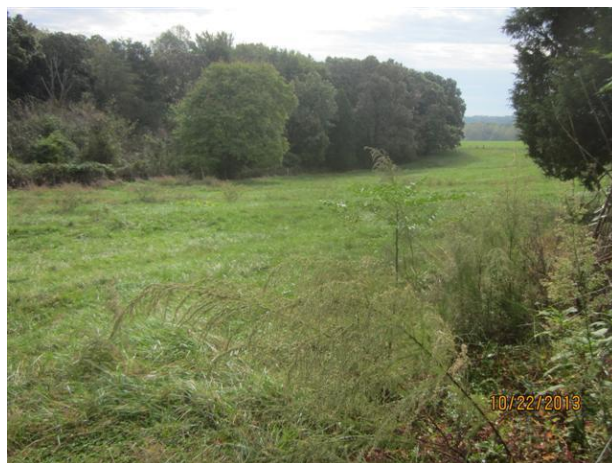
8. The cover crop was well established with no bare areas.
9. Field #2 is in need of cutting.
10. No ponding of water or of septage was observed.
11. The nutrient management plan stipulates that both fields are to be cut *“whenever it reaches 12 inches in height or just before seedhead [sic] emergence”*.

2. Looking SSE from the entrance gate to field #2, down field #2.

12. Please ensure that, in accordance with the approved nutrient management plan, that “areas that develop with less than 80% ground cover by fescue will be re-seeded at a rate of 25lbs./ac. no-tilled in September.”
